SPRUCE RESERVOIR

NDI I.D. PA-00587

PHASE I INSPECTION REPORT  
NATIONAL DAM INSPECTION PROGRAM

SPRUCE RESERVOIR DAM

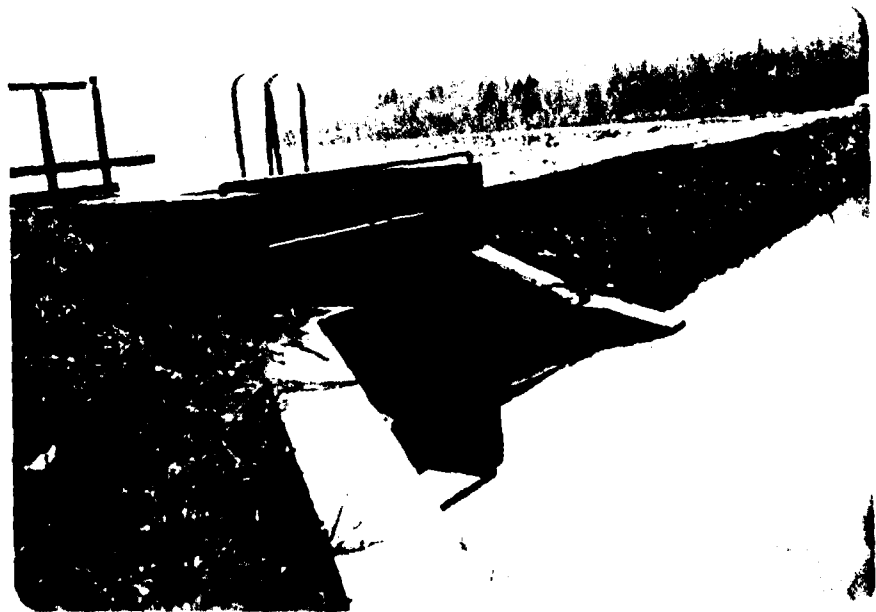
Photograph No. 4

Downstream intake structure. Foreground: diversion channel. Background: reservoir.

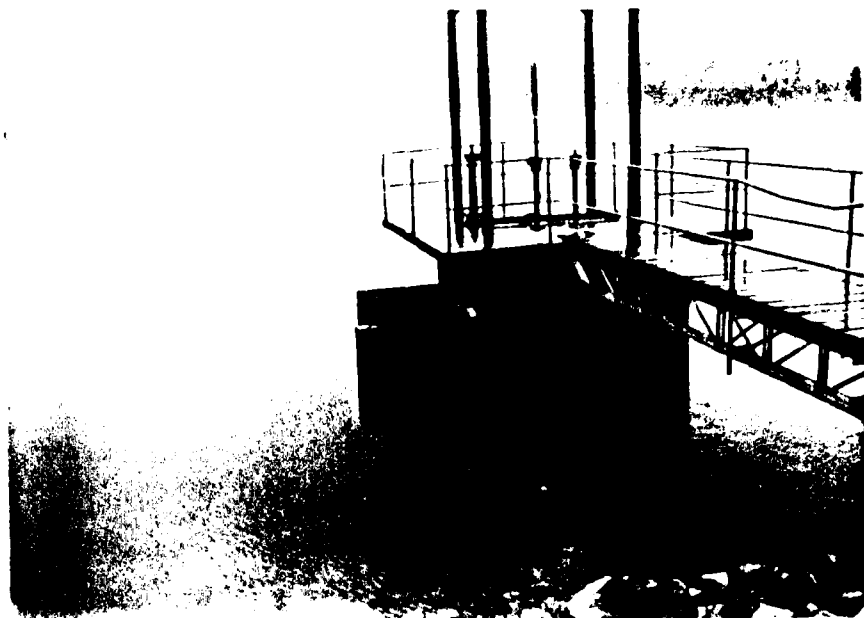
Photograph No. 5  
Reservoir outlet structure.

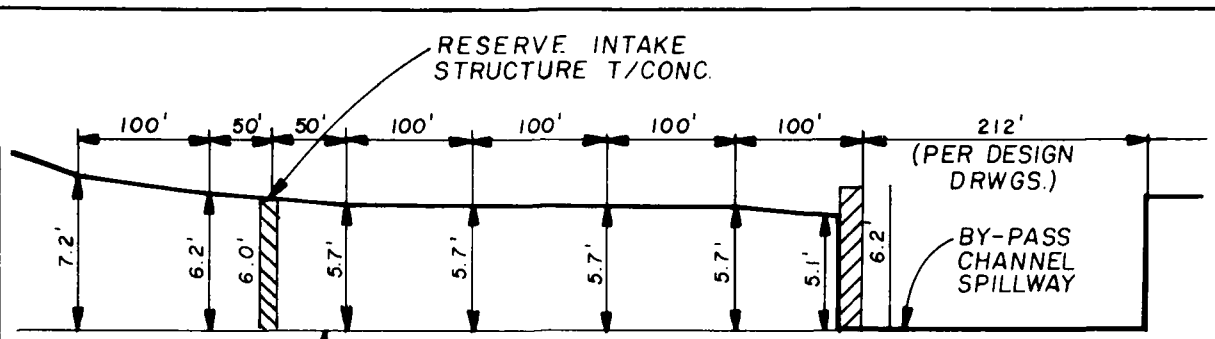
DAM CREST PROFILE  
DIVERSION DIKE LOOKING DOWNSTREAM

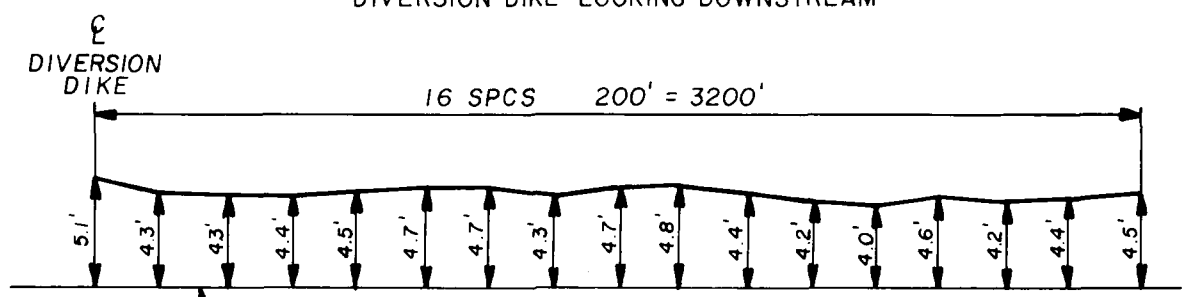
DAM CREST PROFILE  
DIKE ALONG BY-PASS CHANNEL-LOOKING NORTH

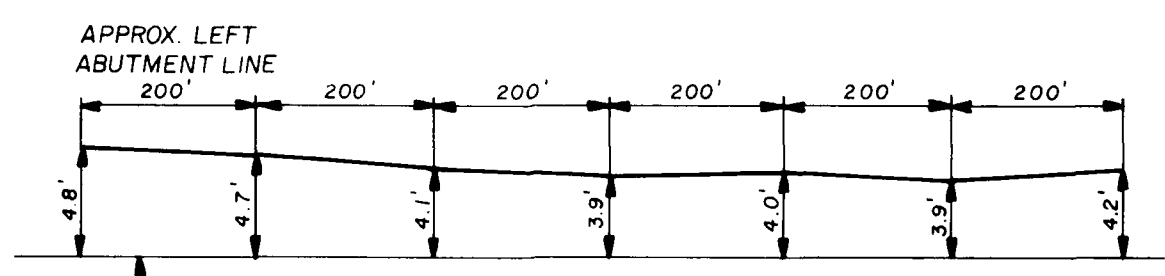
The crest of the dam was surveyed relative to the bypass channel spillway crest level and the crest of the embankment along the upstream side of the reservoir was found to be up to 0.9 foot below the design crest elevation. The lowest point occurred adjacent to the bypass channel left abutment wall. The crest levels of the embankment along the bypass channel and the embankment on the downstream side of the reservoir were found to be essentially at or above the design level. The dam crest profile is illustrated in Plate 9. The downstream slopes were surveyed and found to be reasonably within the design slope of 2H to 1V.

DAM CREST PROFILE  
MAIN D/S EMBANKMENT-LOOKING DOWNSTREAM

2. In conjunction with the detailed evaluation of the dam, the crest of the dam should be surveyed and the low spots filled to design elevation.
3. Brush and trees in the bypass channel below the spillway should be removed.
4. The operational condition of the outlet pipe gate should be evaluated and necessary maintenance performed.
5. Around-the-clock surveillance should be provided during unusually heavy runoff and a formal warning system should be developed to alert the downstream residents in the event of emergencies.
6. The dam and appurtenant structures should be inspected regularly and a formal maintenance manual should be developed for the continued maintenance of the dam.
